Manhole Inspection Summary

Manhole # S53II_001MH

Insp Date: **4/17/08 10:25 AM**

Location Address: **Edison Highway**

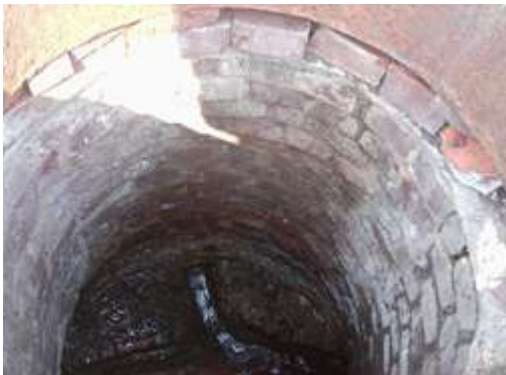
Defect 2

☒ **Leaks**

Frame Leaks

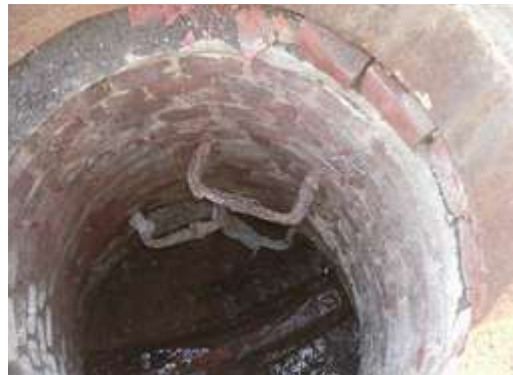
Defect 1

Condition: ☐ Sound ☐ Cracked ☐ Root Intrusion ☒ **Loose Brick** ☐ Deteriorated

Infiltration: ☐ None ☒ **Joint** ☐ Cracks ☒ **Mortar** ☐ Roots ☐ Wall

Loose Bricks

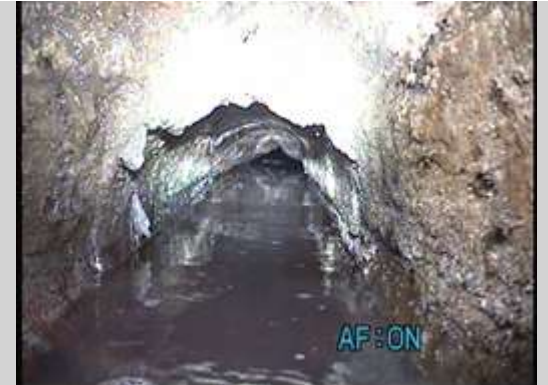
8 in. Circular Gravity Sewer
Pipe Out @ 12 O'Clock

Pipe Height: **8.4** (in.) Rod and Bar (Angled)
Pipe Material: **Clay** ☐ Pipe Lined
Invert Depth: **8.20** (ft.) Flow Characteristics: **Fast**
Deposits: ☒ None ☐ Mud ☐ Sludge ☐ Debris ☐ Grease
Silt Depth: (in.) Deposits Extent:
Infiltration: **None** Pipe Seal Cond: **Sound**

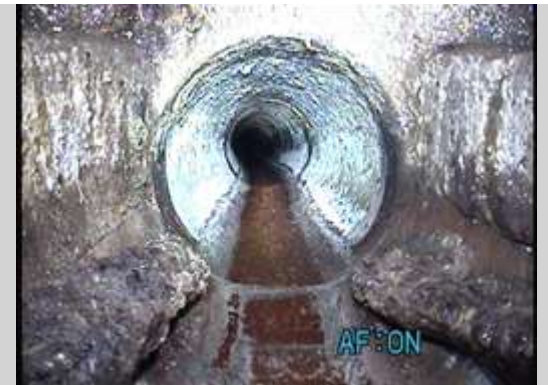
8 in. Circular Gravity Sewer
Pipe In @ 5 O'Clock

Pipe Height: **8.4** (in.) Rod and Bar (Angled)
Pipe Material: **Clay** ☐ Pipe Lined
Invert Depth: **7.60** (ft.) Flow Characteristics: **Fast**
Deposits: ☒ None ☐ Mud ☐ Sludge ☐ Debris ☐ Grease
Silt Depth: (in.) Deposits Extent:
Infiltration: **None** Pipe Seal Cond: **Sound**

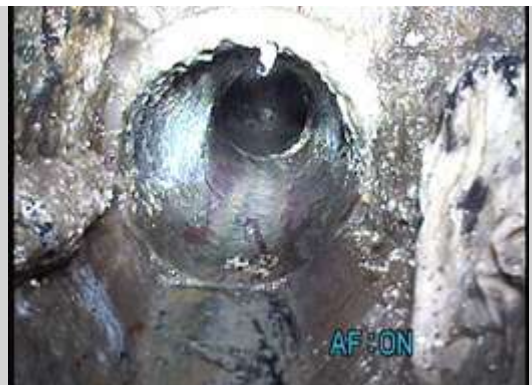
6 in. Circular Gravity Sewer
Pipe In @ 8 O'Clock

Infiltration: **None**

Pipe Seal Cond: **Sound**
